Cliente / Client : Amec Foster Wheeler

Contracto / Contract N°: 15-17S-104851

REPAIR TANK 1638

Lajes Field, Terceira Island, Azores

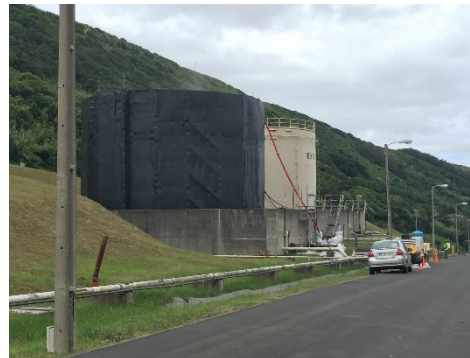
Figura 1– Instalação de sistema de andaime.
Figure 1 – Installation of a scaffolding system.

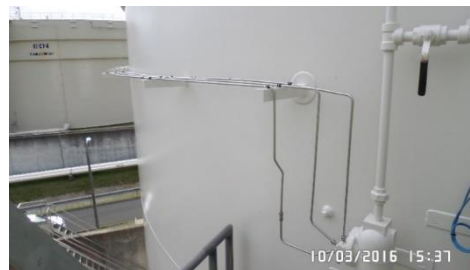
Figura 2– Instalação de tubo da válvula de controlo de nível.
Figure 2 – Installation of control tubing for the overfill valve.

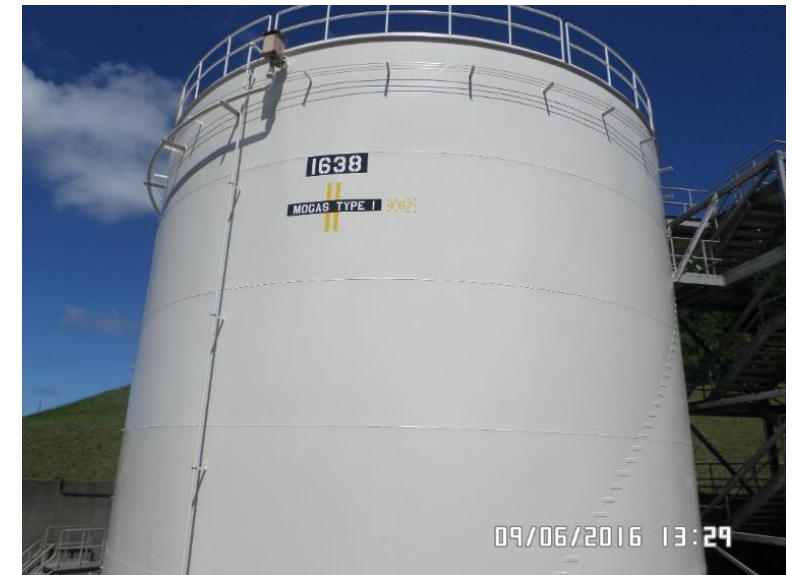
Figura 3 – Pintura anticorrosiva de tanque de gasolina.
Figure 3 – Anticorrosive coating application in a Mogas tank.
